**Flood Control Project Maintenance
Levee Inspections**

Fall 2018 Levee Maintenance Deficiency Summary Report

Sacramento River Basin

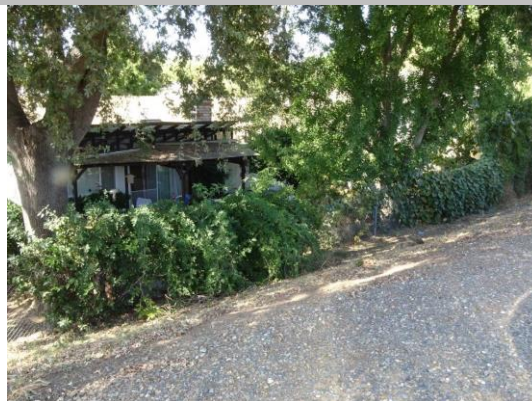
Photo 1 of 1 : FA_2018_NA0001_55_155_20181024_00268.jpg

LM Start	10.59	Rating **	M	Issue No.	155
LM End	10.59	Issue Type +	En	Location *	LS
Category	Earthen Levee			GPS Latitude/Longitude	
				Start	End
Item	Vegetation			38.568892 °	38.568892 °
				-121.353162 °	-121.353162 °
DWR ID	DWR_NA0001_04_s_2012_155				
Comment Code					
V6 : Landscaping					
Inspector Comment					
Trees and bushes are within 10-ft of the levee toe and block visibility.

View of tree and bushes within levee easement. Fall 2018

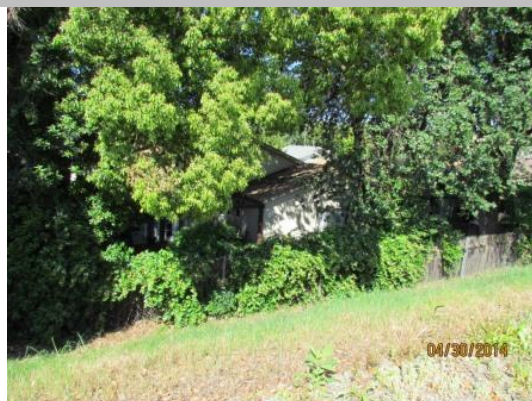
Photo 1 of 1 : FA_2018_NA0001_55_156_20180911_00137.jpg

LM Start	10.60	Rating **	U	Issue No.	156
LM End	10.60	Issue Type +	En	Location *	LS
Category	Earthen Levee			GPS Latitude/Longitude	
				Start	End
Item	Encroachments			38.568713 °	38.568713 °
				-121.353150 °	-121.353150 °
DWR ID	DWR_NA0001_04_s_2012_156				
Comment Code					
FE : Fence					
Inspector Comment					
Chain link fence and landscaping within 10-ft of levee toe.

View of the fence at the landside levee toe obstructing visibility and access.

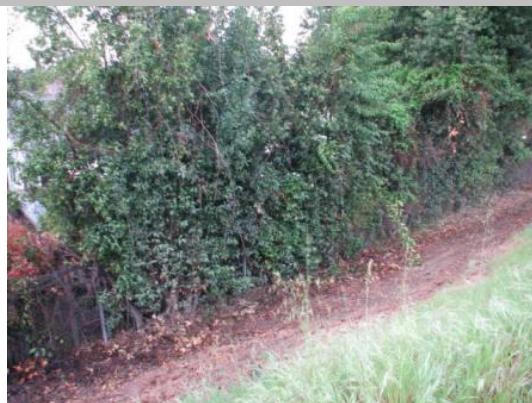
Photo 1 of 1 : FA_2018_NA0001_55_157_20180911_00138.jpg

LM Start	10.61	Rating **	M	Issue No.	157
LM End	10.61	Issue Type +	En	Location *	LS
Category	Earthen Levee			GPS Latitude/Longitude	
				Start	End
Item	Vegetation			38.568608 °	38.568608 °
				-121.353054 °	-121.353054 °
DWR ID	DWR_NA0001_04_s_2012_157				
Comment Code					
V6 : Landscaping					
Inspector Comment					
Tall hedge and vine on levee toe.

03/16/2012 Landscaping obstructs visibility

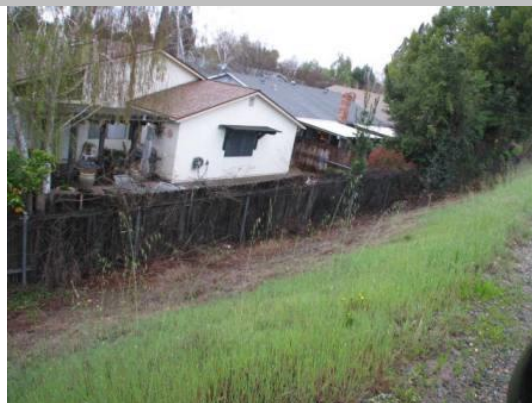
Photo 1 of 1 : FA_2018_NA0001_55_158_20180911_00139.jpg

LM Start	10.62	Rating **	U	Issue No.	158
LM End	10.62	Issue Type +	En	Location *	LS
Category	Earthen Levee			GPS Latitude/Longitude	
				Start	End
Item	Encroachments			38.568355 °	38.568355 °
				-121.353033 °	-121.353033 °
DWR ID	DWR_NA0001_04_s_2012_158				
Comment Code					
FE : Fence					
Inspector Comment					
Wooden privacy fence within 10-ft of levee toe.

03/16/2012 Wood privacy fence completely obstructs access and visibility.

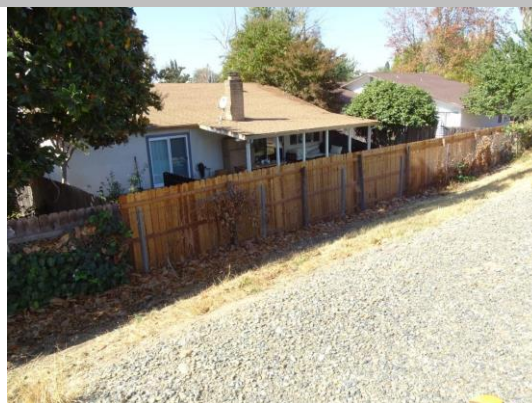
Photo 1 of 2 : FA_2018_NA0001_55_162_20181024_00267.jpg

LM Start	10.70	Rating **	U	Issue No.	162
LM End	10.70	Issue Type +	En	Location *	LS
Category	Earthen Levee			GPS Latitude/Longitude	
				Start	End
Item	Encroachments			38.567402 °	38.567402 °
				-121.352415 °	-121.352415 °
DWR ID	DWR_NA0001_04_s_2012_162				
Comment Code					
FE : Fence					
Inspector Comment					
New wooden fence still within 10-ft of levee toe.

View of new wooden fence at levee toe that blocks visibility. Fall 2018

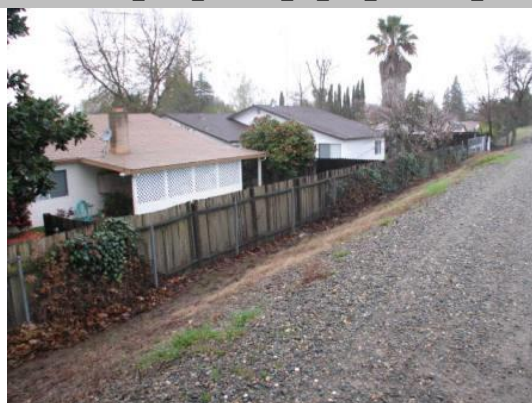
Photo 2 of 2 : FA_2018_NA0001_55_162_20180911_00143.jpg

03/16/2012 Wood privacy fence completely obstructs access and visibility.

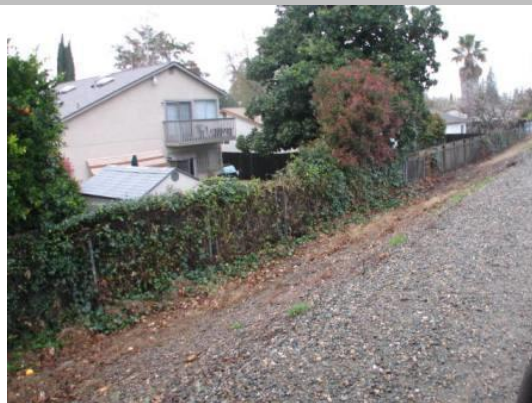
Photo 1 of 1 : FA_2018_NA0001_55_163_20180911_00144.jpg

LM Start	10.71	Rating **	U	Issue No.	163
LM End	10.71	Issue Type +	En	Location *	LS
Category	Earthen Levee			GPS Latitude/Longitude	
				Start	End
Item	Encroachments			38.567250 °	38.567250 °
				-121.352341 °	-121.352341 °
DWR ID	DWR_NA0001_04_s_2012_163				
Comment Code					
FE : Fence					
Inspector Comment					
Wooden privacy fence and landscaping within 10-ft of levee toe.

03/16/2012 Wood privacy fence completely obstructs access and visibility.

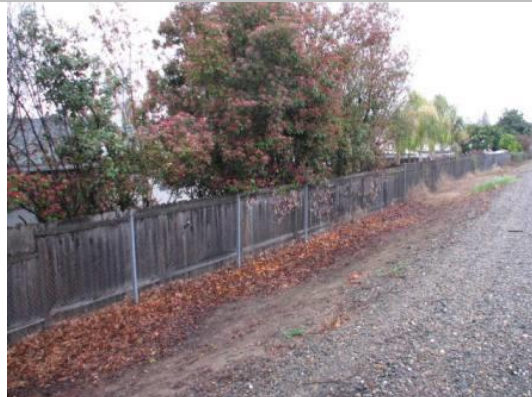
Photo 1 of 1 : FA_2018_NA0001_55_171_20180911_00151.jpg

LM Start	10.76	Rating **	U	Issue No.	171
LM End	10.76	Issue Type +	En	Location *	LS
Category	Earthen Levee			GPS Latitude/Longitude	
				Start	End
Item	Encroachments			38.566499 °	38.566499 °
				-121.351952 °	-121.351952 °
DWR ID	DWR_NA0001_04_s_2012_171				
Comment Code					
FE : Fence					
Inspector Comment					
Wooden privacy fence and tall hedge within 10-ft of levee toe.

03/16/2012 Wood privacy fence completely obstructs access and visibility.

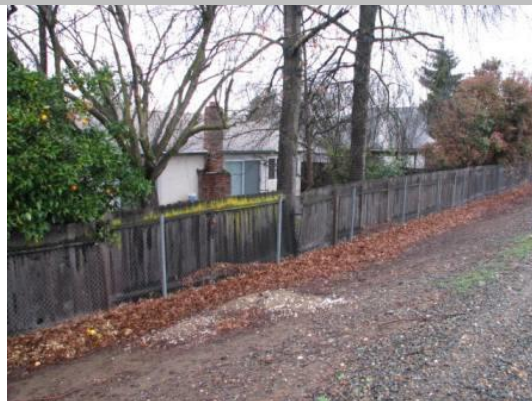
Photo 1 of 1 : FA_2018_NA0001_55_169_20180911_00149.jpg

LM Start	10.77	Rating **	U	Issue No.	169
LM End	10.77	Issue Type +	En	Location *	LS
Category	Earthen Levee			GPS Latitude/Longitude	
				Start	End
Item	Encroachments			38.566399 °	38.566399 °
				-121.351931 °	-121.351931 °
DWR ID	DWR_NA0001_04_s_2012_169				
Comment Code					
FE : Fence					
Inspector Comment					
Wooden privacy fence within 10-ft of levee toe.

03/16/2012 Wood privacy fence completely obstructs access and visibility.

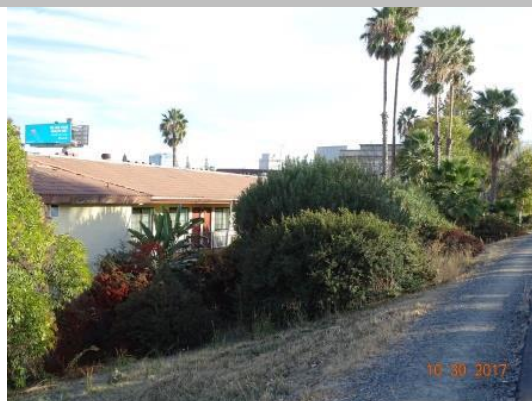
Photo 1 of 1 : FA_2018_NA0001_56_2_20180911_00001.jpg

LM Start	0.10	Rating **	U	Issue No.	2
LM End	0.17	Issue Type +	En	Location *	LS
Category	Earthen Levee			GPS Latitude/Longitude	
				Start	End
Item	Vegetation			38.595044 °	38.594117 °
				-121.506497 °	-121.506377 °
DWR ID	DWR_NA0001_05_s_2012_2				
Comment Code					
V6 : Landscaping					
Inspector Comment					
Landscaping behind Best Western. This appears to be permit 8760, but the landscaping is not maintained per title 23 standards.

View of the landscaping on the landside levee slope obstructing visibility and access. Fall 2017

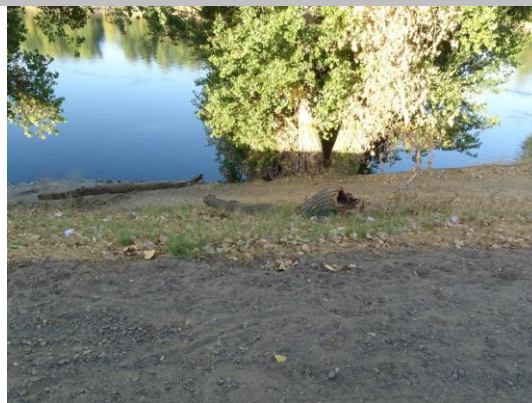
Photo 1 of 1 : FA_2018_NA0001_56_1_20181024_00003.jpg

LM Start	0.22	Rating **	M	Issue No.	1
LM End	0.22	Issue Type +	Ma	Location *	WS
Category	Earthen Levee			GPS Latitude/Longitude	
				Start	End
Item	Encroachments			38.593298 °	38.593298 °
				-121.506230 °	-121.506230 °
DWR ID	DWR_NA0001_05_f_2018_1				
Comment Code					
DE : Debris					
Inspector Comment					
Tree log debris needs to be removed.

View of tree log debris on levee slope. Fall 2018

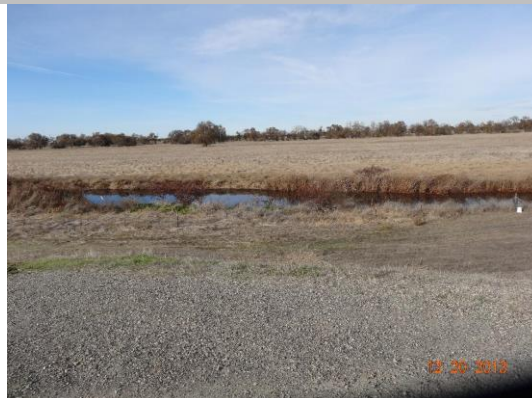
Photo 1 of 3 : UCIP_FA_2018_30706_56559.jpg

Comment Code						
Inspector Comment						
FS_ID:30706 DS_ID:24812 EP_NO: N/A Repair Type: Non-Urgent Crossing Status: Indicator Found UCIP Comments: 08/16/2017 DWR Deferred Maintenance Project (DMP), Vince Rodriguez, forwarded email received from Tim Kerr, General Manager of American River Flood Control District (ARFCD) with file "DWR Eligible Pipes Found in ARFCD" from ARFCD that shows the ownership and location of the pipes Tim Kerr investigated. Owner of this crossing is identified as the City of Sacramento, ARFCD Staff Notes indicate landside DI near Pinedale. (DWR UCIP - O. Magana) 12/20/2013 Unable to confirm if line goes through levee or along landward slope. No permit found. (DWR UCIP - O. Magana) FIELD_STRUCT_DESC: Storm drain manhole located on landside (LS). (no permit has been identified authorizing this structure, structure is owned by the City of Sacramento) FS Date: 12/20/2013

View of waterward side.

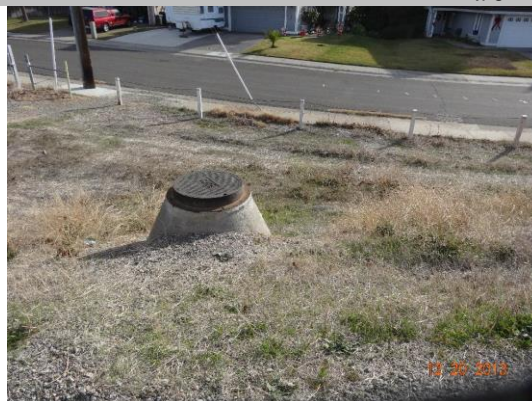
Photo 2 of 3 : UCIP_FA_2018_30706_56558.jpg

Manhole located on landward slope.

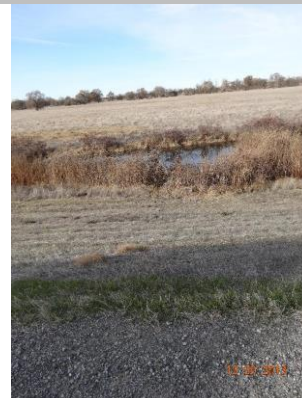
Photo 1 of 3 : UCIP_FA_2018_29223_54002.jpg

Comment Code						
Inspector Comment						
FS_ID:29223 DS_ID:24354 EP_NO: N/A Repair Type: Non-Urgent Crossing Status: Indicator Found UCIP Comments: 08/16/2017 DWR Deferred Maintenance Project (DMP), Vince Rodriguez, forwarded email received from Tim Kerr, General Manager of American River Flood Control District (ARFCD) with file "DWR Eligible Pipes Found in ARFCD" from ARFCD that shows the ownership and location of the pipes Tim Kerr investigated. Owner of this crossing was not identified, ARFCD Staff Notes indicate old pipe between Kelton and Sully (not found). (DWR UCIP - O. Magana) 12/20/2013 Unable to find CM riser and flap gate on waterward end--need to contact owner to determine status of crossing. Manhole found on landward side however unable to determine if manhole is part of this crossing. (DWR UCIP - O. Magana) FIELD_STRUCT_DESC: 24-inch corrugated metal drainage pipe through the levee, 12.5 feet below the crown. Two corrugated metal cutoff walls around pipe. Slide gate in corrugated metal riser and flap gate on waterside (WS) end. Concrete headwalls on both ends, WS and landside (LS). (no permit has been identified authorizing this structure - no owner has been identified) [Additional Reference(s): USACE Sacramento O&M Manual Unit 118 Part 2, August 1959, Drawing No. 1-4-392 of Exhibit B, (Station 440+50)]. FS Date: 12/20/2013

View of waterward side--no evidence of crossing.

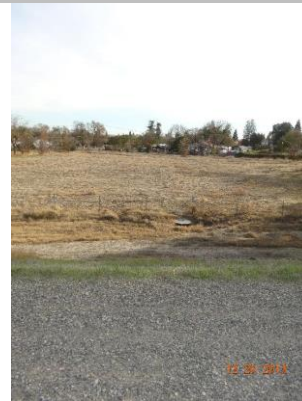
Photo 2 of 3 : UCIP_FA_2018_29223_54001.jpg

View of landward side--manhole on landward toe.

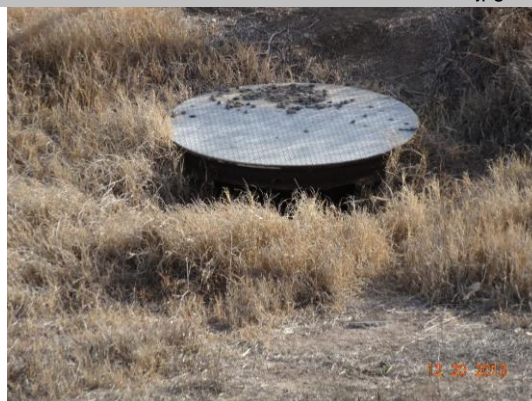
Photo 3 of 3 : UCIP_FA_2018_29223_54000.jpg

Comment Code						
Inspector Comment						
FS_ID:29223 DS_ID:24354 EP_NO: N/A Repair Type: Non-Urgent Crossing Status: Indicator Found UCIP Comments: 08/16/2017 DWR Deferred Maintenance Project (DMP), Vince Rodriguez, forwarded email received from Tim Kerr, General Manager of American River Flood Control District (ARFCD) with file "DWR Eligible Pipes Found in ARFCD" from ARFCD that shows the ownership and location of the pipes Tim Kerr investigated. Owner of this crossing was not identified, ARFCD Staff Notes indicate old pipe between Kelton and Sully (not found). (DWR UCIP - O. Magana) 12/20/2013 Unable to find CM riser and flap gate on waterward end--need to contact owner to determine status of crossing. Manhole found on landward side however unable to determine if manhole is part of this crossing. (DWR UCIP - O. Magana) FIELD_STRUCT_DESC: 24-inch corrugated metal drainage pipe through the levee, 12.5 feet below the crown. Two corrugated metal cutoff walls around pipe. Slide gate in corrugated metal riser and flap gate on waterside (WS) end. Concrete headwalls on both ends, WS and landside (LS). (no permit has been identified authorizing this structure - no owner has been identified) [Additional Reference(s): USACE Sacramento O&M Manual Unit 118 Part 2, August 1959, Drawing No. 1-4-392 of Exhibit B, (Station 440+50)]. FS Date: 12/20/2013

Manhole visible on landward toe.

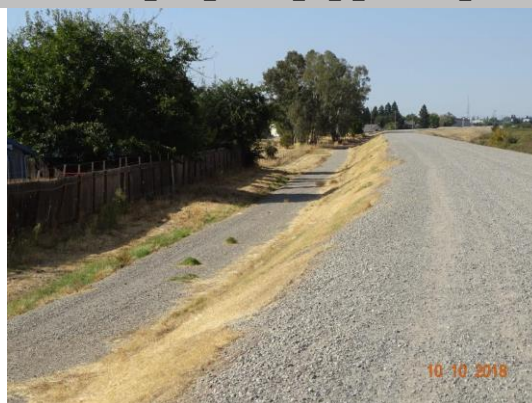
Photo 1 of 1 : FA_2018_NA0001_57_3_20181015_00007.jpg

LM Start	0.96	Rating **	A	Issue No.	3
LM End	0.96	Issue Type +	Ma	Location *	LS
Category	Earthen Levee			GPS Latitude/Longitude	
				Start	End
Item	Vegetation			38.662083 °	38.662083 °
				-121.458561 °	-121.458561 °
DWR ID	DWR_NA0001_06_f_2018_3				
Comment Code					
V1 : Control annual grass and weeds on the levee slopes and easements.					
Inspector Comment					
Landside vegetation is well maintained.

View of landside vegetation. Fall 2018

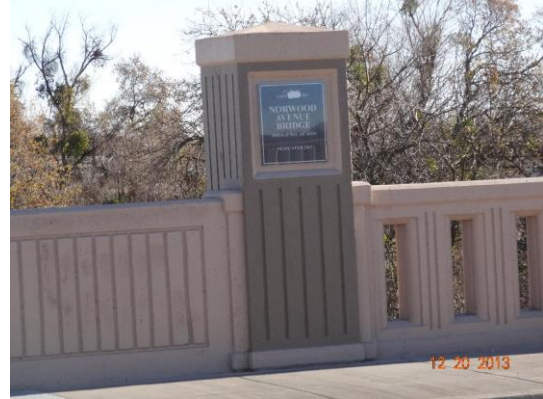
**Flood Control Project Maintenance
Levee Inspections**

American River Flood Control District

Comment Code					
Inspector Comment					
FS_ID:53489 DS_ID:24363 EP_NO: 18641-1 Repair Type: Non-Urgent Crossing Status: Found UCIP Comments: 07/18/2018 Everything appears to be the same as last time. No markers have been placed. This gas line is supposed to be raised to the 200-year water surface elevation. PG&E records for this distribution main indicate that there were no leaks found on the 06/2017 leak survey and the pipeline is operating correctly according to the 12/2016 CP inspection. Crossing is downgraded to "Non-Urgent" until the gas line is raised to the 200-year level. (A. McDonald - DWR UCIP)08/11/2016 Markers still missing. LMA representatives, Tim Kerr and Richard Marck, provided permit for PG&E line to be raised to 200-year water surface elevation. Pipe will be raised on both the right and left banks. Depth below the crown will need to be updated once construction is completed. (DWR UCIP - omagana)12/19/2013 Missing gas line markers -- need to contact owner to determine status. (DWR UCIP - omagana) FIELD_STRUCT_DESC: 4-inch steel natural gas pipeline through the levee, 2 feet below the crown. Corrugated metal (CM) cutoff wall around pipe at the center of the levee. Pipeline is protected by a cage along the side of the bridge. 4-inch gate valve will be installed on the LS approximately 355 feet from levee crown (near Fairbanks Avenue and Norwood Avenue). In case of an emergency related to this pipeline, PG&E has identified the following contacts: PG&E's local pipeline engineer, Mike Aronoff at 916-307-9472 (cell), and Gas Control (north) at 800-442-4743. For non-emergency issues, please contact the local PG&E Gas Pipeline Operations and Maintenance (GPOM) supervisors for the Sacramento region, David Wade at 209-639-1039 (cell), or Ron Hicks at 916-396-9038 (cell). (4-inch pipe installed under Permit No. 3417, 1961 - Pacific Gas and Electric Company [PG&E]; 4-inch pipe removed and replaced under Permit 18641, 2011 - PG&E; 4-inch pipe through levee (both right and left bank) raised above the 200-year water surface elevation under Permit No. 18641-1, 2016 - PG&E) [Additional Reference(s): DWR Levee Log, 2002] FS Date: 7/18/2018

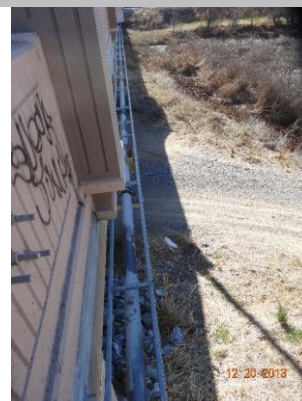
Photo 2 of 3 : UCIP_FA_2018_53489_54062.jpg

Item	DWR UCIP Field Study		38.624843 °	38.624843 °								
			-121.457097 °	-121.457097 °								
DWR ID	24363											
Comment Code												
Inspector Comment												
<p>FS_ID:53489 DS_ID:24363 EP_NO: 18641-1 Repair Type: Non-Urgent Crossing Status: Found UCIP Comments: 07/18/2018 Everything appears to be the same as last time. No markers have been placed. This gas line is supposed to be raised to the 200-year water surface elevation. PG&E records for this distribution main indicate that there were no leaks found on the 06/2017 leak survey and the pipeline is operating correctly according to the 12/2016 CP inspection. Crossing is downgraded to "Non-Urgent" until the gas line is raised to the 200-year level. (A. McDonald - DWR UCIP)08/11/2016 Markers still missing. LMA representatives, Tim Kerr and Richard Marck, provided permit for PG&E line to be raised to 200-year water surface elevation. Pipe will be raised on both the right and left banks. Depth below the crown will need to be updated once construction is completed. (DWR UCIP - omagana)12/19/2013 Missing gas line markers -- need to contact owner to determine status. (DWR UCIP - omagana) FIELD_STRUCT_DESC: 4-inch steel natural gas pipeline through the levee, 2 feet below the crown. Corrugated metal (CM) cutoff wall around pipe at the center of the levee. Pipeline is protected by a cage along the side of the bridge. 4-inch gate valve will be installed on the LS approximately 355 feet from levee crown (near Fairbanks Avenue and Norwood Avenue). In case of an emergency related to this pipeline, PG&E has identified the following contacts: PG&E's local pipeline engineer, Mike Aronoff at 916-307-9472 (cell), and Gas Control (north) at 800-442-4743. For non-emergency issues, please contact the local PG&E Gas Pipeline Operations and Maintenance (GPOM) supervisors for the Sacramento region, David Wade at 209-639-1039 (cell), or Ron Hicks at 916-396-9038 (cell). (4-inch pipe installed under Permit No. 3417, 1961 - Pacific Gas and Electric Company [PG&E]; 4-inch pipe removed and replaced under Permit 18641, 2011 - PG&E; 4-inch pipe through levee (both right and left bank) raised above the 200-year water surface elevation under Permit No. 18641-1, 2016 - PG&E) [Additional Reference(s): DWR Levee Log, 2002] FS Date: 7/18/2018</p>

View of pipe attached to bridge.

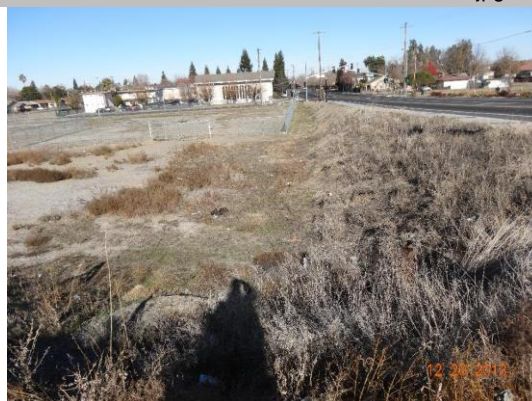
Photo 3 of 3 : UCIP_FA_2018_53489_54060.jpg

Comment Code						
Inspector Comment						
FS_ID:53489 DS_ID:24363 EP_NO: 18641-1 Repair Type: Non-Urgent Crossing Status: Found UCIP Comments: 07/18/2018 Everything appears to be the same as last time. No markers have been placed. This gas line is supposed to be raised to the 200-year water surface elevation. PG&E records for this distribution main indicate that there were no leaks found on the 06/2017 leak survey and the pipeline is operating correctly according to the 12/2016 CP inspection. Crossing is downgraded to "Non-Urgent" until the gas line is raised to the 200-year level. (A. McDonald - DWR UCIP)08/11/2016 Markers still missing. LMA representatives, Tim Kerr and Richard Marck, provided permit for PG&E line to be raised to 200-year water surface elevation. Pipe will be raised on both the right and left banks. Depth below the crown will need to be updated once construction is completed. (DWR UCIP - omagana)12/19/2013 Missing gas line markers -- need to contact owner to determine status. (DWR UCIP - omagana) FIELD_STRUCT_DESC: 4-inch steel natural gas pipeline through the levee, 2 feet below the crown. Corrugated metal (CM) cutoff wall around pipe at the center of the levee. Pipeline is protected by a cage along the side of the bridge. 4-inch gate valve will be installed on the LS approximately 355 feet from levee crown (near Fairbanks Avenue and Norwood Avenue). In case of an emergency related to this pipeline, PG&E has identified the following contacts: PG&E's local pipeline engineer, Mike Aronoff at 916-307-9472 (cell), and Gas Control (north) at 800-442-4743. For non-emergency issues, please contact the local PG&E Gas Pipeline Operations and Maintenance (GPOM) supervisors for the Sacramento region, David Wade at 209-639-1039 (cell), or Ron Hicks at 916-396-9038 (cell). (4-inch pipe installed under Permit No. 3417, 1961 - Pacific Gas and Electric Company [PG&E]; 4-inch pipe removed and replaced under Permit 18641, 2011 - PG&E; 4-inch pipe through levee (both right and left bank) raised above the 200-year water surface elevation under Permit No. 18641-1, 2016 - PG&E) [Additional Reference(s): DWR Levee Log, 2002] FS Date: 7/18/2018

View of LS.

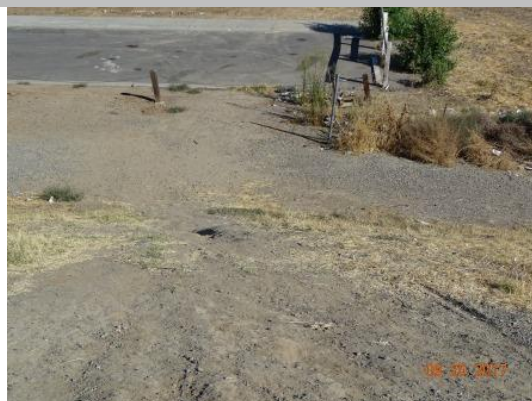
Photo 1 of 1 : FA_2018_NA0001_58_5_20180911_00004.jpg

LM Start	1.05	Rating **	A/W	Issue No.	5
LM End	1.05	Issue Type +	Ma	Location *	LS
Category	Earthen Levee			GPS Latitude/Longitude	
				Start	End
Item	Slope Stability			38.625862 °	38.625862 °
				-121.450978 °	-121.450978 °
DWR ID	DWR_NA0001_07_f_2017_5				
Comment Code					
S2 : Repair the levee slope damaged by foot traffic and prevent access where possible.					
Inspector Comment					
Minor erosion on the slope should be monitored.

View of the damaged levee slope.

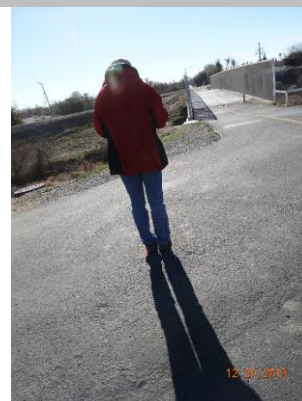
Photo 2 of 3 : UCIP_FA_2018_40803_48511.jpg

Comment Code						
Inspector Comment						
FS_ID:40803 DS_ID:24447 EP_NO: 16466 Repair Type: Non-Urgent Crossing Status: Found UCIP Comments: 06/14/2017 This crossing is scheduled to be cut and replaced as part of Sacramento Area Flood Control (SAFCA) North Area Streams (NAS) Levee Improvement Project: City of Sacramento Utility Permit Modifications Along Arcade Creek Levees. Unable to confirm when pipe will be replaced. Need to coordinate with owner and DWR FPIIB Inspector to determine when project is expected to start. (DWR UCIP - O. Magana). 12/20/2013 Need to contact owner to determine if crossings are at this location are associated with Permit number 16466--unable to confirm crossings. (DWR UCIP - O. Magana) FIELD_STRUCT_DESC: Two 6-inch and one 2-inch concrete encased steel utility conduits through the levee, all approximately 2 feet below the crown. Manhole located on the levee crown. (two 6-inch pipes and one 2-inch pipe authorized under Permit No. 16466, 1995 - Sacramento Municipal Utility District [SMUD]; modifications to existing crossings, cut and replace existing two 6-inch pipes and one 2-inch pipe, work authorized under Permit No. 16466, 2016 - SMUD) FS Date: 12/20/2013

View of levee crown and estimate where crossings cross levee.

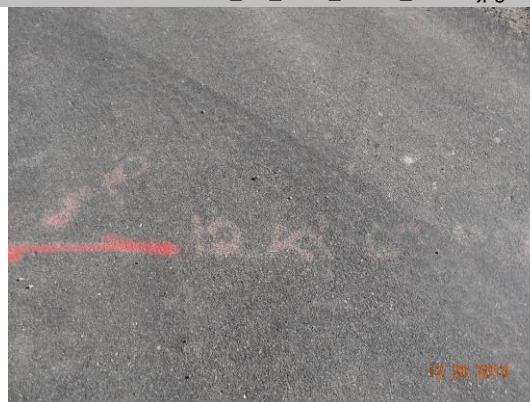
Photo 3 of 3 : UCIP_FA_2018_40803_48510.jpg

Underground Service Alert (USA) faint utility markers visible on levee crown.

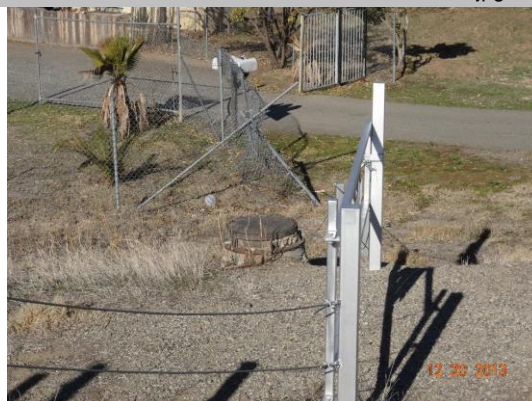
Photo 1 of 1 : UCIP_FA_2018_29275_54199.jpg

Comment Code						
Inspector Comment						
FS_ID:29275						
DS_ID:24553						
EP_NO: N/A						
Repair Type: Non-Urgent						
Crossing Status: Found						
UCIP Comments: Only manhole present--need to coordinate with owner to determine if crossing is still presnt and whether manhole corresponds to this crossing.						
FIELD_STRUCT_DESC: 8-inch (not 10-inch as indicated in desk study) sewer pipe through the levee, 7.5 feet below the crown. Floodgates within the levee across the channel, installed under Permit No. 14480 (1986) by the City of Sacramento, Department of Public Works.						
[Additional Reference(s): DWR Levee Log, 2002]						
FS Date: 12/20/2013

Manhole visible on landward side.

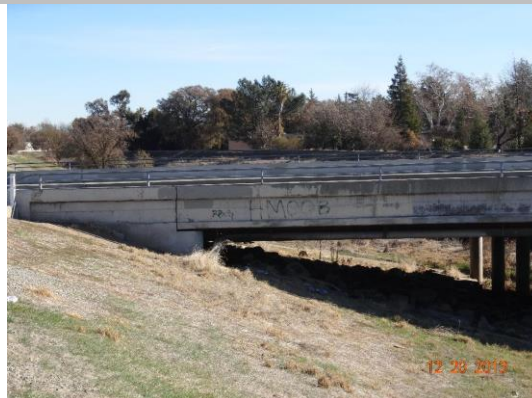
Photo 1 of 3 : UCIP_FA_2018_53491_75853.jpg

Comment Code					
Inspector Comment					
FS_ID:53491 DS_ID:24443 EP_NO: 15152-1 Repair Type: Non-Urgent Crossing Status: Found UCIP Comments: 07/18/2018 This pipeline was abandoned. It was cut and capped at the north end of the Rio Linda Blvd bridge. The section of pipe that goes under the levee is open on the WS end. This gas line is supposed to be raised to the 200-year water surface elevation. PG&E records for this distribution main indicate that there were no leaks found on the 07/2017 leak survey and the pipeline is operating correctly according to the 12/2016 CP inspection. Crossing downgraded to "Non-Urgent" pending documentation that this gas line has been abandoned properly. (A. McDonald - DWR UCIP)8/11/2016 Markers still missing. Will need to update depth below crown once construction is completed. (DWR UCIP - omagana)12/20/2013 Unable to confirm if crossing is the same one authorized through permit. (DWR UCIP - omagana) FIELD_STRUCT_DESC: *ABANDONED* 4-inch steel natural gas main through the levee, 2.5 feet below the crown. Vent on the waterside (WS) shoulder. Pipeline was abandoned, cut, and capped at the north end of the Rio Linda Blvd bridge. In case of an emergency related to this pipeline, PG&E has identified the following contacts: PG&E's local pipeline engineer, Mike Aronoff at 916-307-9472 (cell), and Gas Control (north) at 800-442-4743. For non-emergency issues, please contact the local PG&E Gas Pipeline Operations and Maintenance (GPOM) supervisors for the Sacramento region, David Wade at 209-639-1039 (cell), or Ron Hicks at 916-396-9038 (cell). (4-inch line installed under Permit No. 15152, 1989 - Pacific Gas and Electric Company [PG&E]; 4-inch will be raised above the 200-year water surface elevation within the levee crown under Permit No. 15152-1, 2016 - PG&E). FS Date: 7/18/2018

View of WS.

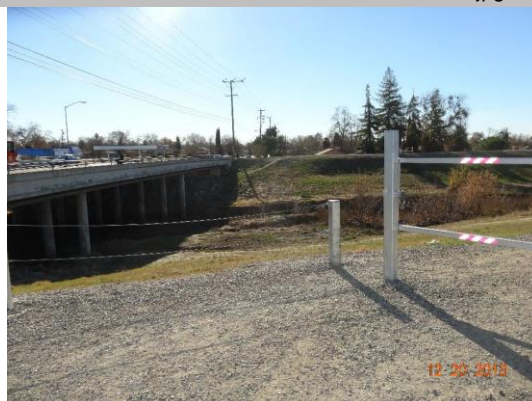
Photo 2 of 3 : UCIP_FA_2018_53491_75854.jpg

Comment Code						
Inspector Comment						
FS_ID:53491 DS_ID:24443 EP_NO: 15152-1 Repair Type: Non-Urgent Crossing Status: Found UCIP Comments: 07/18/2018 This pipeline was abandoned. It was cut and capped at the north end of the Rio Linda Blvd bridge. The section of pipe that goes under the levee is open on the WS end. This gas line is supposed to be raised to the 200-year water surface elevation. PG&E records for this distribution main indicate that there were no leaks found on the 07/2017 leak survey and the pipeline is operating correctly according to the 12/2016 CP inspection. Crossing downgraded to "Non-Urgent" pending documentation that this gas line has been abandoned properly. (A. McDonald - DWR UCIP)8/11/2016 Markers still missing. Will need to update depth below crown once construction is completed. (DWR UCIP - omagana)12/20/2013 Unable to confirm if crossing is the same one authorized through permit. (DWR UCIP - omagana) FIELD_STRUCT_DESC: *ABANDONED* 4-inch steel natural gas main through the levee, 2.5 feet below the crown. Vent on the waterside (WS) shoulder. Pipeline was abandoned, cut, and capped at the north end of the Rio Linda Blvd bridge. In case of an emergency related to this pipeline, PG&E has identified the following contacts: PG&E's local pipeline engineer, Mike Aronoff at 916-307-9472 (cell), and Gas Control (north) at 800-442-4743. For non-emergency issues, please contact the local PG&E Gas Pipeline Operations and Maintenance (GPOM) supervisors for the Sacramento region, David Wade at 209-639-1039 (cell), or Ron Hicks at 916-396-9038 (cell). (4-inch line installed under Permit No. 15152, 1989 - Pacific Gas and Electric Company [PG&E]; 4-inch will be raised above the 200-year water surface elevation within the levee crown under Permit No. 15152-1, 2016 - PG&E). FS Date: 7/18/2018

No signs of crossing visible through levee or channel.

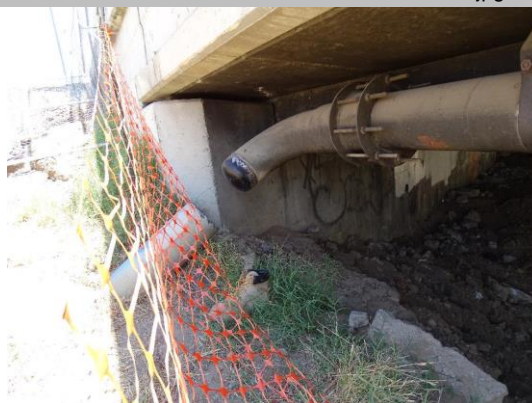
Photo 3 of 3 : UCIP_FA_2018_53491_77630.jpg

UCIP Comments: 07/18/2018 This pipeline was abandoned. It was cut and capped at the north end of the Rio Linda Blvd bridge. The section of pipe that goes under the levee is open on the WS end. This gas line is supposed to be raised to the 200-year water surface elevation. PG&E records for this distribution main indicate that there were no leaks found on the 07/2017 leak survey and the pipeline is operating correctly according to the 12/2016 CP inspection. Crossing downgraded to "Non-Urgent" pending documentation that this gas line has been abandoned properly. (A. McDonald - DWR UCIP)8/11/2016 Markers still missing. Will need to update depth below crown once construction is completed. (DWR UCIP - omagana)12/20/2013 Unable to confirm if crossing is the same one authorized through permit. (DWR UCIP - omagana) FIELD_STRUCT_DESC: *ABANDONED* 4-inch steel natural gas main through the levee, 2.5 feet below the crown. Vent on the waterside (WS) shoulder. Pipeline was abandoned, cut, and capped at the north end of the Rio Linda Blvd bridge. In case of an emergency related to this pipeline, PG&E has identified the following contacts: PG&E's local pipeline engineer, Mike Aronoff at 916-307-9472 (cell), and Gas Control (north) at 800-442-4743. For non-emergency issues, please contact the local PG&E Gas Pipeline Operations and Maintenance (GPOM) supervisors for the Sacramento region, David Wade at 209-639-1039 (cell), or Ron Hicks at 916-396-9038 (cell). (4-inch line installed under Permit No. 15152, 1989 - Pacific Gas and Electric Company [PG&E]; 4-inch will be raised above the 200-year water surface elevation within the levee crown under Permit No. 15152-1, 2016 - PG&E).

Natural gas pipeline grouted and capped on the WS at N end of Rio Linda Blvd bridge.

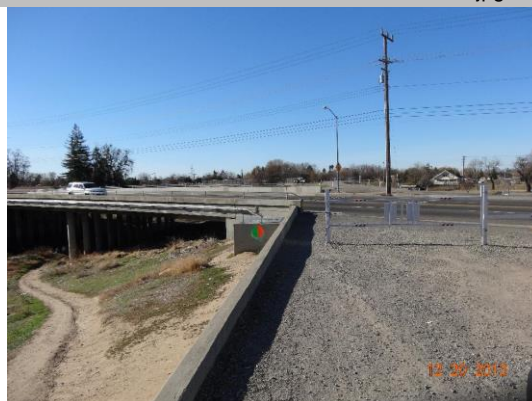
Photo 1 of 3 : UCIP_FA_2018_29301_54278.jpg

Comment Code						
Inspector Comment						
FS_ID:29301 DS_ID:24370 EP_NO: N/A Repair Type: No Action Needed Crossing Status: Found UCIP Comments: 08/16/2017 DWR Deferred Maintenance Project (DMP), Vince Rodriguez, forwarded email received from Tim Kerr, General Manager of American River Flood Control District (ARFCD) with file "DWR Eligible Pipes Found in ARFCD" from ARFCD that shows the ownership and location of the pipes Tim Kerr investigated. Owner of this crossing is identified as the City of Sacramento, ARFCD Staff Notes indicate Arcade CK just upstream of Rio Linda. (DWR UCIP - O. Magana) FIELD_STRUCT_DESC: 24-inch corrugated metal (CM) drainage pipe through the levee, 11 feet below the crown. Slide gate in CM riser on the waterside (WS) slope. Flap gate on the WS end. Concrete headwalls on both ends, WS and landside (LS). (no permit has been identified authorizing this structure, structure is owned by the City of Sacramento) [Additional Reference(s): DWR Levee Log, 2002. USACE Sacramento O&M Manual Unit 118, Part No. 2, October 1959, Drawing No. 1-4-392 Exhibit B, (Station 65+73)] FS Date: 12/20/2013

View of flood wall along waterward side.

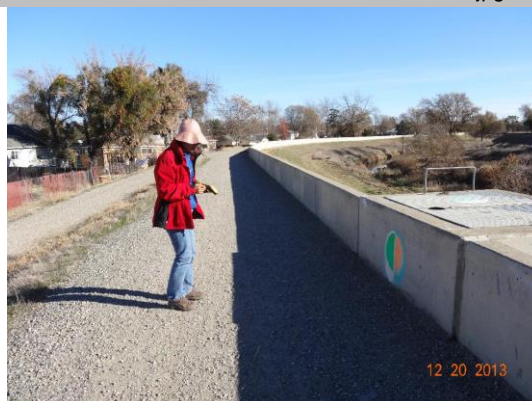
Photo 1 of 3 : UCIP_FA_2018_29302_54282.jpg

FS_ID:29302
DS_ID:24371
EP_NO: N/A
Repair Type: No Action Needed
Crossing Status: Found
UCIP Comments: 08/16/2017 DWR Deferred Maintenance Project (DMP), Vince Rodriguez, forwarded email received from Tim Kerr, General Manager of American River Flood Control District (ARFCD) with file "DWR Eligible Pipes Found in ARFCD" from ARFCD that shows the ownership and location of the pipes Tim Kerr investigated. Owner of this crossing is identified as the City of Sacramento, ARFCD Staff Notes indicate Arcade Ck near Rivera Dr at Branch St. (DWR UCIP - O. Magana)
06/14/2017 This crossing is scheduled to be cut and replaced as part of Sacramento Area Flood Control (SAFCA) North Area Streams (NAS) Levee Improvement Project: City of Sacramento Utility Permit Modifications Along Arcade Creek Levees. Unable to confirm when pipe will be replaced. Need to coordinate with owner and DWR FPIIB Inspector to determine when project is expected to start. (DWR UCIP - O. Magana).

View of levee crown--flood wall located along waterward shoulder.

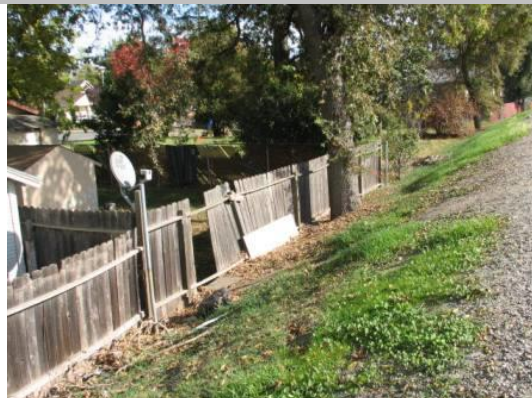
Photo 1 of 1 : FA_2018_NA0001_58_4_20180911_00003.jpg

LM Start	1.58	Rating **	U	Issue No.	4
LM End	1.58	Issue Type +	En	Location *	LS
Category	Earthen Levee			GPS Latitude/Longitude	
				Start	End
Item	Encroachments			38.627707 °	38.627707 °
				-121.441965 °	-121.441965 °
DWR ID	DWR_NA0001_07_s_2012_4				
Comment Code					
FE : Fence					
Inspector Comment					
Wooden privacy fence is within 10-ft of the levee toe.

11/17/2011 Wooden privacy fence is constructed at the toe.

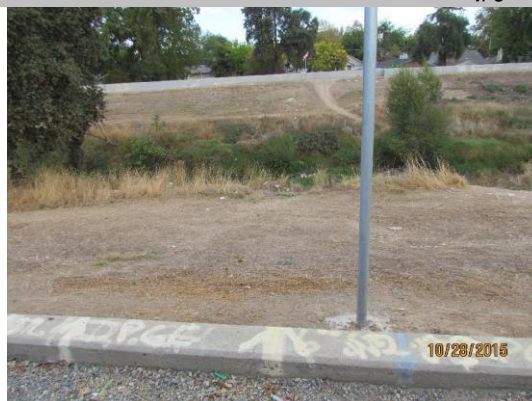
Photo 1 of 3 : UCIP_FA_2018_52672_74733.jpg

Comment Code					
Inspector Comment					
FS_ID:52672					
DS_ID:24835					
EP_NO: N/A					
Repair Type: Non-Urgent					
Crossing Status: Indicator Found					
UCIP Comments: 08/11/2017 PG&E records for DFM 0614-13 indicate that there were no observations found on the 07/2017 patrol, no leaks found on the 04/2017 leak survey, and the pipeline is operating correctly according to the 11/2016 CP inspection. (DWR UCIP - A. McDonald)11/12/15 Markers have been installed on both levees--confirmed during 2015 DWR Fall Inspection. Need to coordinate with PG&E to determine permit for this crossing.12/19/13 Gas line - no markers visible. No permit available.					
FIELD_STRUCT_DESC: 2 of 2: 6-inch gasoline of unknown material through the levee and under the channel at an unknown depth. In case of an emergency related to this pipeline, PG&E has identified the following contacts: PG&E's local pipeline engineer, Mike Aronoff at 916-307-9472 (cell), and Gas Control (north) at 800-442-4743. For non-emergency issues, please contact the local PG&E Gas Pipeline Operations and Maintenance (GPOM) supervisors for the Sacramento region, David Wade at 209-639-1039 (cell), or Ron Hicks at 916-396-9038 (cell).

Markers installed through both levees in 2015.

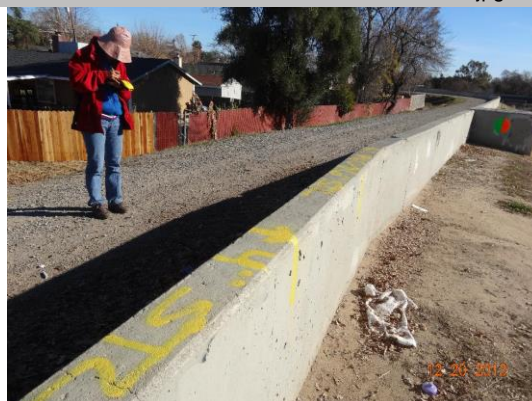
Photo 2 of 3 : UCIP_FA_2018_52672_57525.jpg

Comment Code						
Inspector Comment						
FS_ID:52672 DS_ID:24835 EP_NO: N/A Repair Type: Non-Urgent Crossing Status: Indicator Found UCIP Comments: 08/11/2017 PG&E records for DFM 0614-13 indicate that there were no observations found on the 07/2017 patrol, no leaks found on the 04/2017 leak survey, and the pipeline is operating correctly according to the 11/2016 CP inspection. (DWR UCIP - A. McDonald)11/12/15 Markers have been installed on both levees--confirmed during 2015 DWR Fall Inspection. Need to coordinate with PG&E to determine permit for this crossing.12/19/13 Gas line - no markers visible. No permit available. FIELD_STRUCT_DESC: 2 of 2: 6-inch gasline of unknown material through the levee and under the channel at an unknown depth. In case of an emergency related to this pipeline, PG&E has identified the following contacts: PG&E's local pipeline engineer, Mike Aronoff at 916-307-9472 (cell), and Gas Control (north) at 800-442-4743. For non-emergency issues, please contact the local PG&E Gas Pipeline Operations and Maintenance (GPOM) supervisors for the Sacramento region, David Wade at 209-639-1039 (cell), or Ron Hicks at 916-396-9038 (cell). FS Date: 12/20/2013

Underground service alert (USA) markings visible on floodwall.

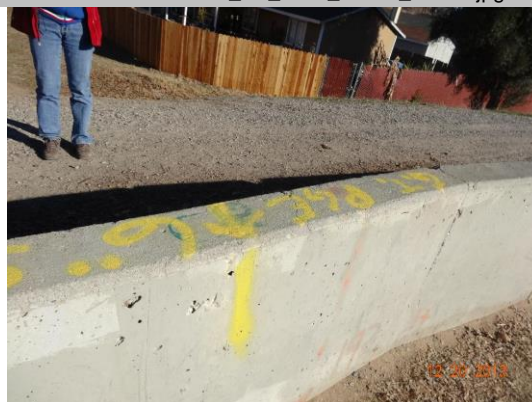
Photo 3 of 3 : UCIP_FA_2018_52672_57524.jpg

6-inch gas line through levee at an unknown depth.

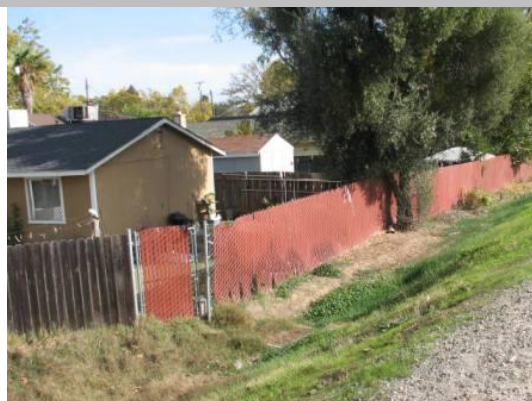
Photo 1 of 1 : FA_2018_NA0001_58_29_20180911_00026.jpg

LM Start	1.61	Rating **	M	Issue No.	29
LM End	1.61	Issue Type +	En	Location *	LS
Category	Earthen Levee			GPS Latitude/Longitude	
				Start	End
Item	Encroachments			38.627733 °	38.627733 °
				-121.441415 °	-121.441415 °
DWR ID	DWR_NA0001_07_s_2012_29				
Comment Code					
FE : Fence					
Inspector Comment					
Privacy fence is within 10-ft of the levee toe.

11/17/2011 Privacy fence is constructed at the toe.

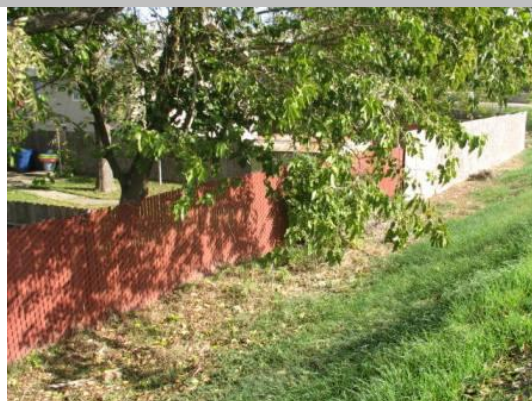
Photo 1 of 1 : FA_2018_NA0001_58_27_20180911_00024.jpg

LM Start	1.63	Rating **	U	Issue No.	27
LM End	1.63	Issue Type +	En	Location *	LS
Category	Earthen Levee			GPS Latitude/Longitude	
				Start	End
Item	Encroachments			38.627681 °	38.627681 °
				-121.441021 °	-121.441021 °
DWR ID	DWR_NA0001_07_s_2012_27				
Comment Code					
FE : Fence					
Inspector Comment					
Privacy fence and overgrown trees are within 10-ft of the levee toe.

11/17/2011 Privacy fence is constructed at the toe.

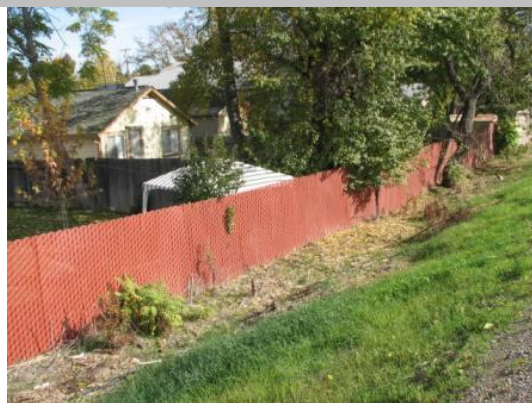
Photo 1 of 1 : FA_2018_NA0001_58_28_20180911_00025.jpg

LM Start	1.63	Rating **	M	Issue No.	28
LM End	1.63	Issue Type +	En	Location *	LS
Category	Earthen Levee			GPS Latitude/Longitude	
				Start	End
Item	Encroachments			38.627668 °	38.627668 °
				-121.441018 °	-121.441018 °
DWR ID	DWR_NA0001_07_s_2012_28				
Comment Code					
FE : Fence					
Inspector Comment					
Privacy fence is within 10-ft of the levee toe.

11/17/2011 Privacy fence is constructed at the toe.

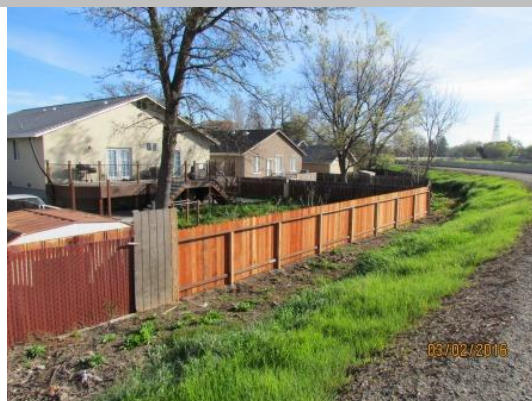
Photo 1 of 1 : FA_2018_NA0001_58_26_20180911_00023.jpg

LM Start	1.64	Rating **	U	Issue No.	26
LM End	1.64	Issue Type +	En	Location *	LS
Category	Earthen Levee			GPS Latitude/Longitude	
				Start	End
Item	Encroachments			38.627667 °	38.627667 °
				-121.440837 °	-121.440837 °
DWR ID	DWR_NA0001_07_s_2012_26				
Comment Code					
FE : Fence					
Inspector Comment					
Wooden privacy fence is within 10-ft of the levee toe.

View of the wooden fence at the landside levee toe.

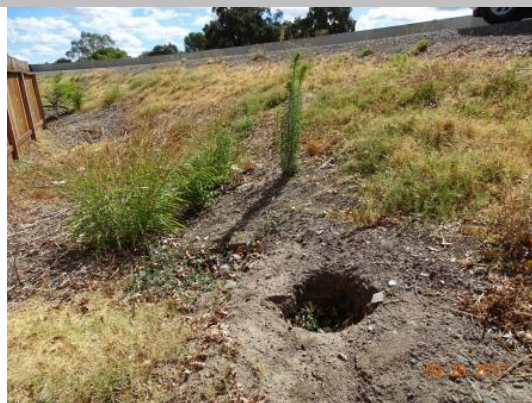
Photo 1 of 1 : FA_2018_NA0001_58_18_20180911_00017.jpg

LM Start	1.64	Rating **	M	Issue No.	18
LM End	1.64	Issue Type +	Ma	Location *	LS
Category	Earthen Levee			GPS Latitude/Longitude	
				Start	End
Item	Animal Control			38.627670 °	38.627670 °
				-121.440814 °	-121.440814 °
DWR ID	DWR_NA0001_07_f_2017_18				
Comment Code					
A3 : No rodents visible, but rodent burrows visible; need to backfill and compact or grout burrows.					
Inspector Comment

View of the rodent hole that needs to be backfilled.

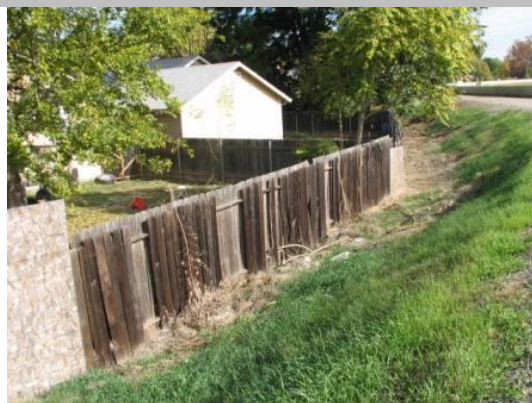
Photo 1 of 1 : FA_2018_NA0001_58_25_20180911_00022.jpg

LM Start	1.65	Rating **	U	Issue No.	25
LM End	1.65	Issue Type +	En	Location *	LS
Category	Earthen Levee			GPS Latitude/Longitude	
				Start	End
Item	Encroachments			38.627677 °	38.627677 °
				-121.440629 °	-121.440629 °
DWR ID	DWR_NA0001_07_s_2012_25				
Comment Code					
FE : Fence					
Inspector Comment					
Wooden privacy fence is within 10-ft of the levee toe.

11/17/2011 Wooden privacy fence is constructed at the toe.

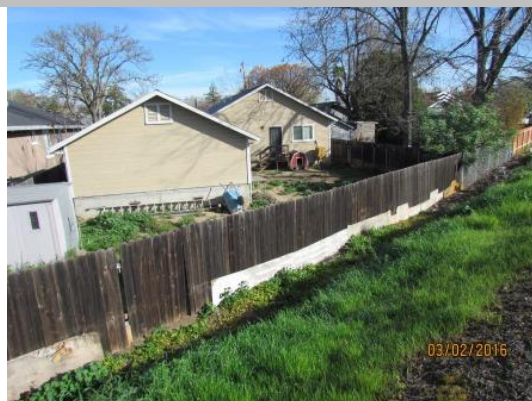
Photo 1 of 1 : FA_2018_NA0001_58_40_20180911_00033.jpg

LM Start	1.66	Rating **	U	Issue No.	40
LM End	1.66	Issue Type +	En	Location *	LS
Category	Earthen Levee			GPS Latitude/Longitude	
				Start	End
Item	Encroachments			38.627727 °	38.627727 °
				-121.440442 °	-121.440442 °
DWR ID	DWR_NA0001_07_s_2016_40				
Comment Code					
FE : Fence					
Inspector Comment

View of the fence at the landside levee toe.

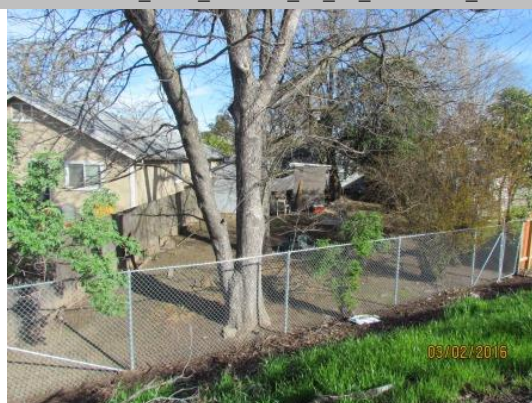
Photo 1 of 1 : FA_2018_NA0001_58_41_20180911_00034.jpg

LM Start	1.67	Rating **	M	Issue No.	41
LM End	1.67	Issue Type +	En	Location *	LS
Category	Earthen Levee			GPS Latitude/Longitude	
				Start	End
Item	Encroachments			38.627803 °	38.627803 °
				-121.440270 °	-121.440270 °
DWR ID	DWR_NA0001_07_s_2016_41				
Comment Code					
FE : Fence					
Inspector Comment

View of the fence at the landside levee toe.

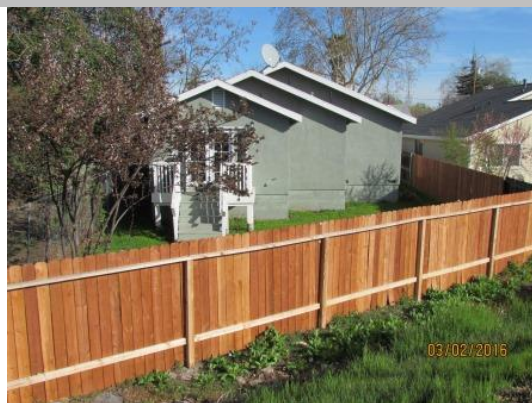
Photo 1 of 1 : FA_2018_NA0001_58_44_20180911_00036.jpg

LM Start	1.68	Rating **	U	Issue No.	44
LM End	1.68	Issue Type +	En	Location *	LS
Category	Earthen Levee			GPS Latitude/Longitude	
				Start	End
Item	Encroachments			38.627874 °	38.627874 °
				-121.440134 °	-121.440134 °
DWR ID	DWR_NA0001_07_s_2016_44				
Comment Code					
FE : Fence					
Inspector Comment

View of the fence at the landside levee toe.

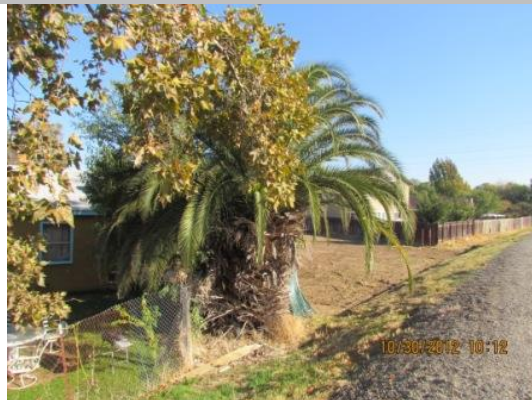
Photo 1 of 1 : FA_2018_NA0001_58_24_20180911_00021.jpg

LM Start	1.72	Rating **	A/W	Issue No.	24
LM End	1.72	Issue Type +	En	Location *	LS
Category	Earthen Levee			GPS Latitude/Longitude	
				Start	End
Item	Vegetation			38.628086°	38.628086°
				-121.439544°	-121.439544°
DWR ID	DWR_NA0001_07_s_2012_24				
Comment Code					
V6 : Landscaping					
Inspector Comment					
Palm tree was trimmed up.

View of palm tree within 10-ft of the levee toe trimmed up from previous inspection.

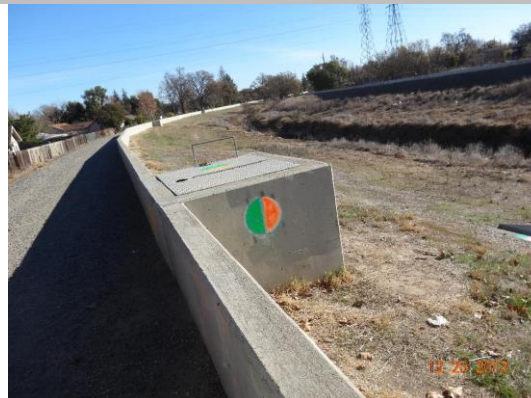
Photo 2 of 3 : UCIP_FA_2018_29324_54307.jpg

Comment Code					
Inspector Comment					
FS_ID:29324 DS_ID:24373 EP_NO: N/A Repair Type: No Action Needed Crossing Status: Found UCIP Comments: 08/16/2017 DWR Deferred Maintenance Project (DMP), Vince Rodriguez, forwarded email received from Tim Kerr, General Manager of American River Flood Control District (ARFCD) with file "DWR Eligible Pipes Found in ARFCD" from ARFCD that shows the ownership and location of the pipes Tim Kerr investigated. Owner of this crossing is identified as the City of Sacramento, ARFCD Staff Notes indicate Arcade Ck. (DWR UCIP - O. Magana) 06/14/2017 This crossing is scheduled to be cut and replaced as part of Sacramento Area Flood Control (SAFCA) North Area Streams (NAS) Levee Improvement Project: City of Sacramento Utility Permit Modifications Along Arcade Creek Levees. Unable to confirm when pipe will be replaced. Need to coordinate with owner and DWR FPIIB Inspector to determine when project is expected to start. (DWR UCIP - O. Magana). FIELD_STRUCT_DESC: 24-inch corrugated metal (CM) drainage pipe through the levee, 7.8 feet below the crown. Concrete headwalls on both waterside (WS) and landside (LS) ends. Slide gate inside corrugated metal (CM) riser located on the WS slope. Flap gate is located on the WS end. (no permit has been identified authorizing this structure, structure is owned by the City of Sacramento) [Additional Reference(s): DWR Levee Log, 2002. USACE Sacramento O&M Manual Unit 118, Part No. 2, October 1959, Drawing No. 1-4-392 Exhibit B, (Station 77+12)] FS Date: 12/20/2013

Floodwall along waterward shoulder.

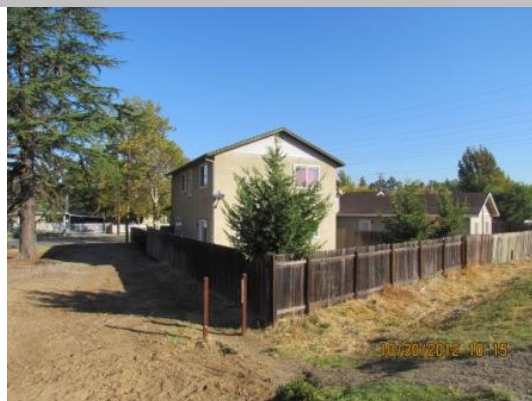
Photo 1 of 1 : FA_2018_NA0001_58_23_20180911_00020.jpg

LM Start	1.74	Rating **	U	Issue No.	23
LM End	1.74	Issue Type +	En	Location *	LS
Category	Earthen Levee			GPS Latitude/Longitude	
				Start	End
Item	Encroachments			38.628221°	38.628221°
				-121.439138°	-121.439138°
DWR ID	DWR_NA0001_07_s_2012_23				
Comment Code					
FE : Fence					
Inspector Comment					
Wooden fence and cedar trees are within 10-ft of levee toe.

View of wooden privacy fence constructed at the toe.

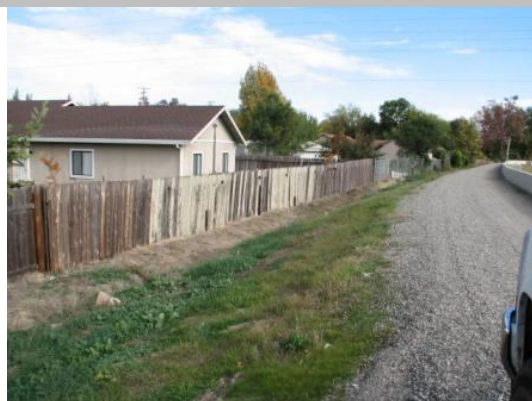
Photo 1 of 1 : FA_2018_NA0001_58_9_20180911_00008.jpg

LM Start	1.75	Rating **	U	Issue No.	9
LM End	1.75	Issue Type +	En	Location *	LS
Category	Earthen Levee			GPS Latitude/Longitude	
				Start	End
Item	Encroachments			38.628197°	38.628197°
				-121.438863°	-121.438863°
DWR ID	DWR_NA0001_07_s_2012_9				
Comment Code					
FE : Fence					
Inspector Comment					
Wooden privacy fence is within 10-ft of the levee toe.

11/17/2011 Wooden privacy fence is constructed at the toe.

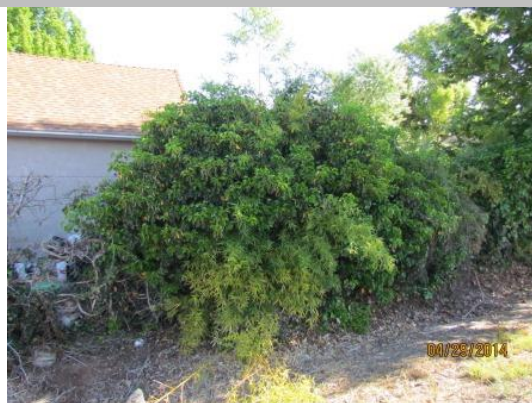
Photo 1 of 1 : FA_2018_NA0001_58_10_20180911_00009.jpg

LM Start	1.79	Rating **	U	Issue No.	10
LM End	1.79	Issue Type +	En	Location *	LS
Category	Earthen Levee			GPS Latitude/Longitude	
				Start	End
Item	Vegetation			38.628273 °	38.628273 °
				-121.438255 °	-121.438255 °
DWR ID	DWR_NA0001_07_s_2012_10				
Comment Code					
V6 : Landscaping					
Inspector Comment					
Ivy and other landscape plantings have grown up chain link fence on the levee toe. Building is within 10-ft of the levee toe. Prunings are on the levee slope.

Landscaping has grown over the fence and obstructs visibility and access.

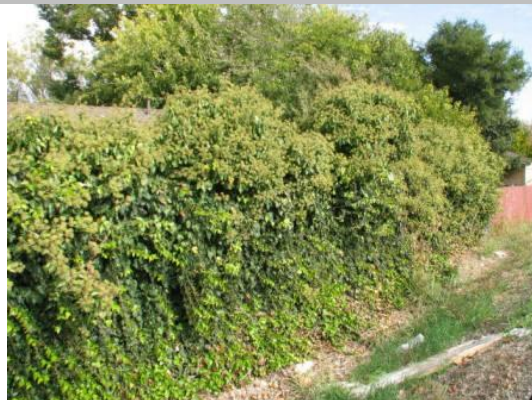
Photo 1 of 1 : FA_2018_NA0001_58_11_20180911_00010.jpg

LM Start	1.80	Rating **	U	Issue No.	11
LM End	1.80	Issue Type +	En	Location *	LS
Category	Earthen Levee			GPS Latitude/Longitude	
				Start	End
Item	Vegetation			38.628297 °	38.628297 °
				-121.437995 °	-121.437995 °
DWR ID	DWR_NA0001_07_f_2012_11				
Comment Code					
V6 : Landscaping					
Inspector Comment					
Dense ivy and landscaping planted on chain link fence on levee toe. Porch and awning are within 10-ft of the levee toe.

11/17/2011 Overgrown vegetation obstructs visibility and access.

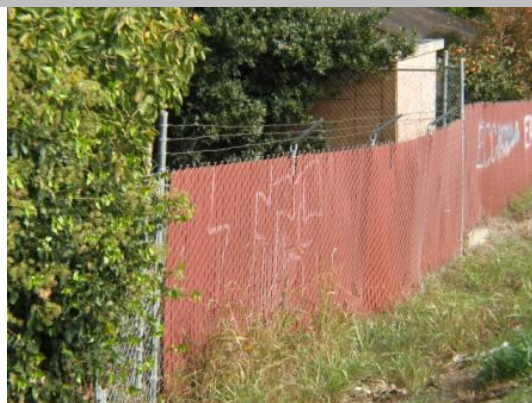
Photo 1 of 1 : FA_2018_NA0001_58_12_20180911_00011.jpg

LM Start	1.81	Rating **	U	Issue No.	12
LM End	1.81	Issue Type +	En	Location *	LS
Category	Earthen Levee			GPS Latitude/Longitude	
				Start	End
Item	Encroachments			38.628307 °	38.628307 °
				-121.437842 °	-121.437842 °
DWR ID	DWR_NA0001_07_s_2012_12				
Comment Code					
FE : Fence					
Inspector Comment					
Chain link privacy fence with barbed wire is within 10-ft of levee toe.

11/17/2011 Barbed wire topped privacy fence is located at the toe.

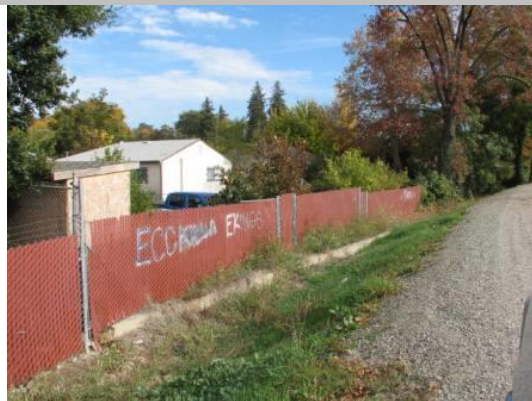
Photo 1 of 1 : FA_2018_NA0001_58_13_20180911_00012.jpg

LM Start	1.82	Rating **	U	Issue No.	13
LM End	1.82	Issue Type +	En	Location *	LS
Category	Earthen Levee			GPS Latitude/Longitude	
				Start	End
Item	Encroachments			38.628303 °	38.628303 °
				-121.437693 °	-121.437693 °
DWR ID	DWR_NA0001_07_s_2012_13				
Comment Code					
FE : Fence					
Inspector Comment					
Chain link privacy fence is within 10-ft of levee toe.

11/17/2011 Privacy fence is located at the toe.

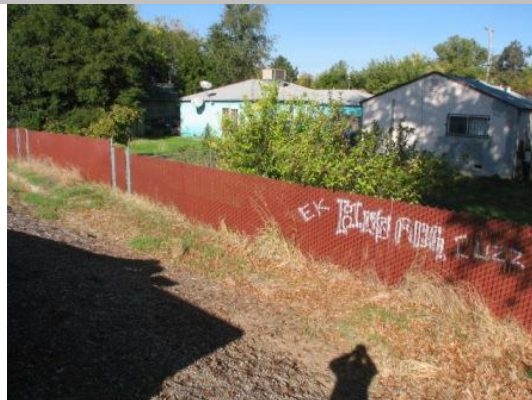
Photo 1 of 1 : FA_2018_NA0001_58_14_20180911_00013.jpg

LM Start	1.83	Rating **	U	Issue No.	14
LM End	1.83	Issue Type +	En	Location *	LS
Category	Earthen Levee			GPS Latitude/Longitude	
				Start	End
Item	Encroachments			38.628303°	38.628303°
				-121.437530°	-121.437530°
DWR ID	DWR_NA0001_07_s_2012_14				
Comment Code					
FE : Fence					
Inspector Comment					
Chain link privacy fence is within 10-ft of levee toe.

Fall 2009 photo of privacy fence within 10-ft of the levee toe obstructs visibility and access.
